TIMBER LAKE DAM

CAMPBELL COUNTY, VIRGINIA

VA. NO. 03102

# PHASE I INSPECTION REPORT

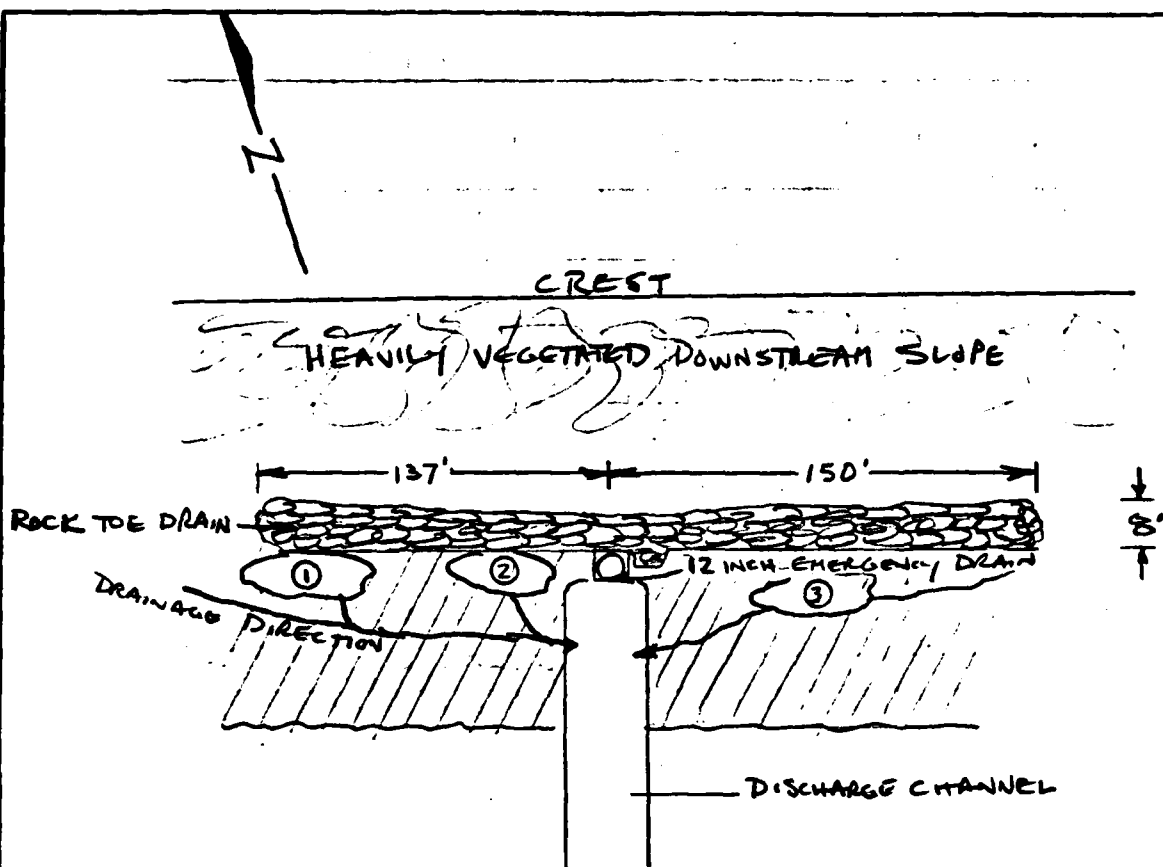
SHEET NO. 1 OF 2  
JOB NO. V80107

- ① WET AREA
- ② SEEPAGE AT LESS THAN 1 GPM; IRON STAINING; 40'x30'
- ③ SEEPAGE AT LESS THAN 1 GPM; IRON STAINING

//// SATURATED GROUND; GENERALLY EXTENDS 50 FT BELOW TOE OF DRAIN; CONSIDERABLY MORE MOISTURE ON RIGHT SIDE OF OUTLET PIPE.

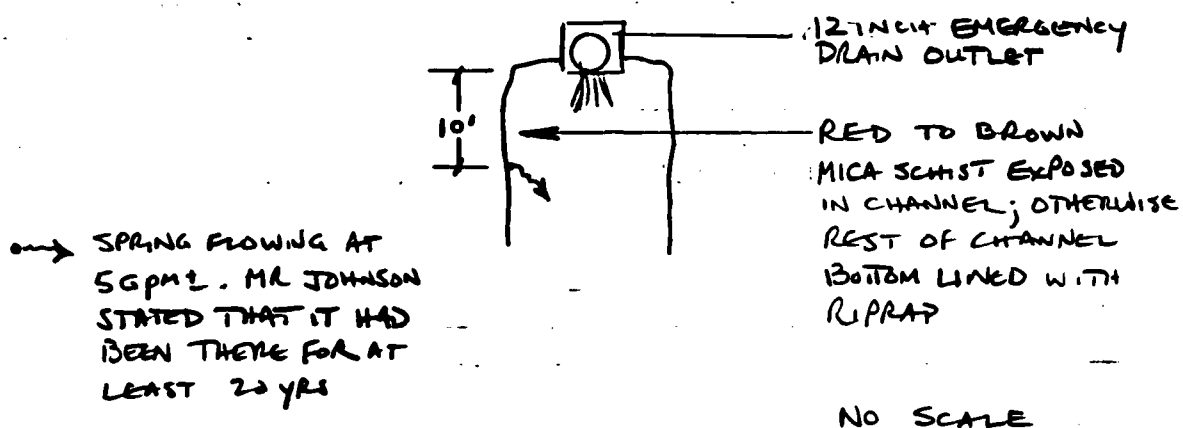
### SPRING LOCATION

was also observed along the right side of the drain outfall channel, 10 ft from the end of the pipe. Flow was estimated at 5 gpm (see Sheet 2, Appendix III).

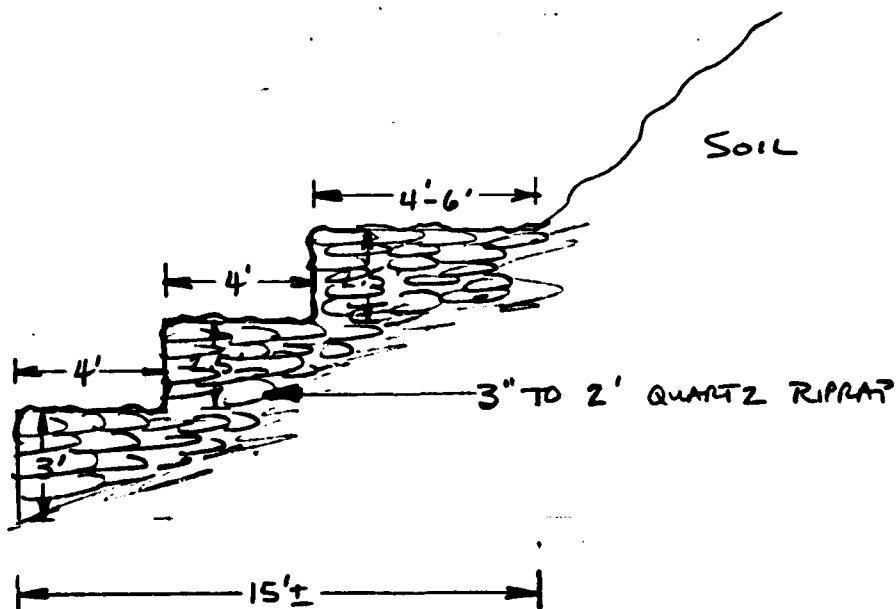
### ROCK TOE DRAIN 50 FT ± LEFT OF OUTLET

6.2.2 Subdrainage and Seepage: A benched 8 ft high toe drain extends approximately 185 ft along the downstream slope (see Sheet 1, Appendix III). The rock toe drain appears to be functioning properly, as no saturated zones or seeps were noted on the downstream embankment above the toe. However, a saturated zone extends to approximately 50 ft beyond the lowest point of the toe drain. This may represent seepage through the foundation, or merely seepage through the rock since no outlet drains were provided.
